**DEPARTMENT OF TRANSPORTATION****DIVISION OF ENGINEERING SERVICES**

Contract #: 04-0120F4Cty: SF/ALA Rte: 80 PM: 13.2/13.9File #: 69.28**WELDING INSPECTION REPORT****Resident Engineer:**Siegenthaler, Peter**Address:** 333 Burma Road**City:** Oakland, CA 94607**Report No:** WIR-017866**Date Inspected:** 18-Oct-2010**Project Name:** SAS Superstructure**OSM Arrival Time:** 700**Prime Contractor:** American Bridge/Fluor Enterprises, a JV**OSM Departure Time:** 1900**Contractor:** Zhenhua Port Machinery Company, Ltd (ZPMC), Changxing Island **Location:** Shanghai, China**CWI Name:** An Qing Xiang**CWI Present:** Yes No**Inspected CWI report:** Yes No N/A**Rod Oven in Use:** Yes No N/A**Electrode to specification:** Yes No N/A**Weld Procedures Followed:** Yes No N/A**Qualified Welders:** Yes No N/A**Verified Joint Fit-up:** Yes No N/A**Approved Drawings:** Yes No N/A**Approved WPS:** Yes No N/A**Delayed / Cancelled:** Yes No N/A**Bridge No:** 34-0006**Component:** Orthotropic Box Girder( OBG)**Summary of Items Observed:**

OBG # TRIAL ASSEMBLY YARD

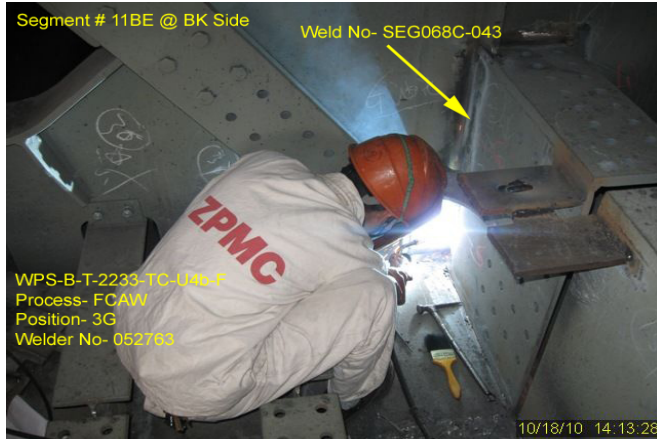
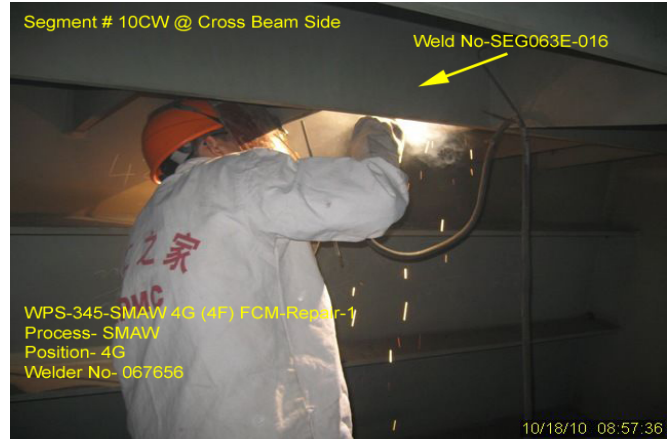
This QA inspector observed ZPMC qualified welding personnel identified as 067656 perform Shielded Metal Arc Welding (SMAW), weld joint identified as SEG063E-016; located On Orthotropic Box Girder (OBG) Bottom Plate to Side Plate CJP Weld; excavated weld due to Flatness rejected areas. The Critical Welding Repair Report (CWRR) was B-CWR2000. ZPMC Quality Control (QC) is identified as Mr. Zhang Qiang. The welding variables recorded by QC appeared to comply with the Applicable WPS-345-SMAW 4G (4F) FCM Repair-1 See the attached Photo.
